**Assessing the Impact of Coastal Processes on Archaeological Sites in Loíza
Puerto Rico: Integrating Geographic Information System (GIS), Remote
Sensing, and Numerical Modeling Techniques**

Loderay I. M. Bracero Marrero

A dissertation submitted to the Environmental Sciences Department, College of
Natural Sciences, Río Piedras Campus in partial fulfillment of the requirements for
the degree of

May 9, 2022

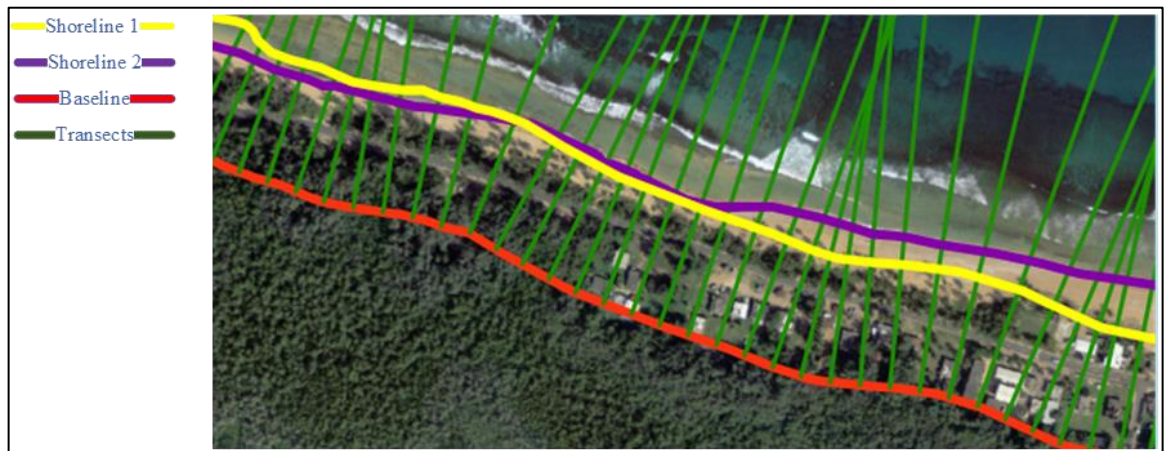
Figure 2.3: Data Inputs and Outputs When Forecasting New Shorelines Using the Digital Shoreline Analysis System

I defined the HWL as the highest point where the water reached and avoided digitizing storm-induced lines. With these shorelines, six periods were compared over the short- and long-term. The six shorelines also allowed me to forecast and project future shoreline positions for 2032 and 2042. DSAS, which is an add-in or extension inside ArcGIS Desktop (ESRI, 2016), is the primary tool used to calculate rates and other statistics and forecast new shorelines (Himmelstoss et al., 2018). An example of the data imported by the user (shoreline and baseline) and the transects generated by the tool is given in Figure 2.3.

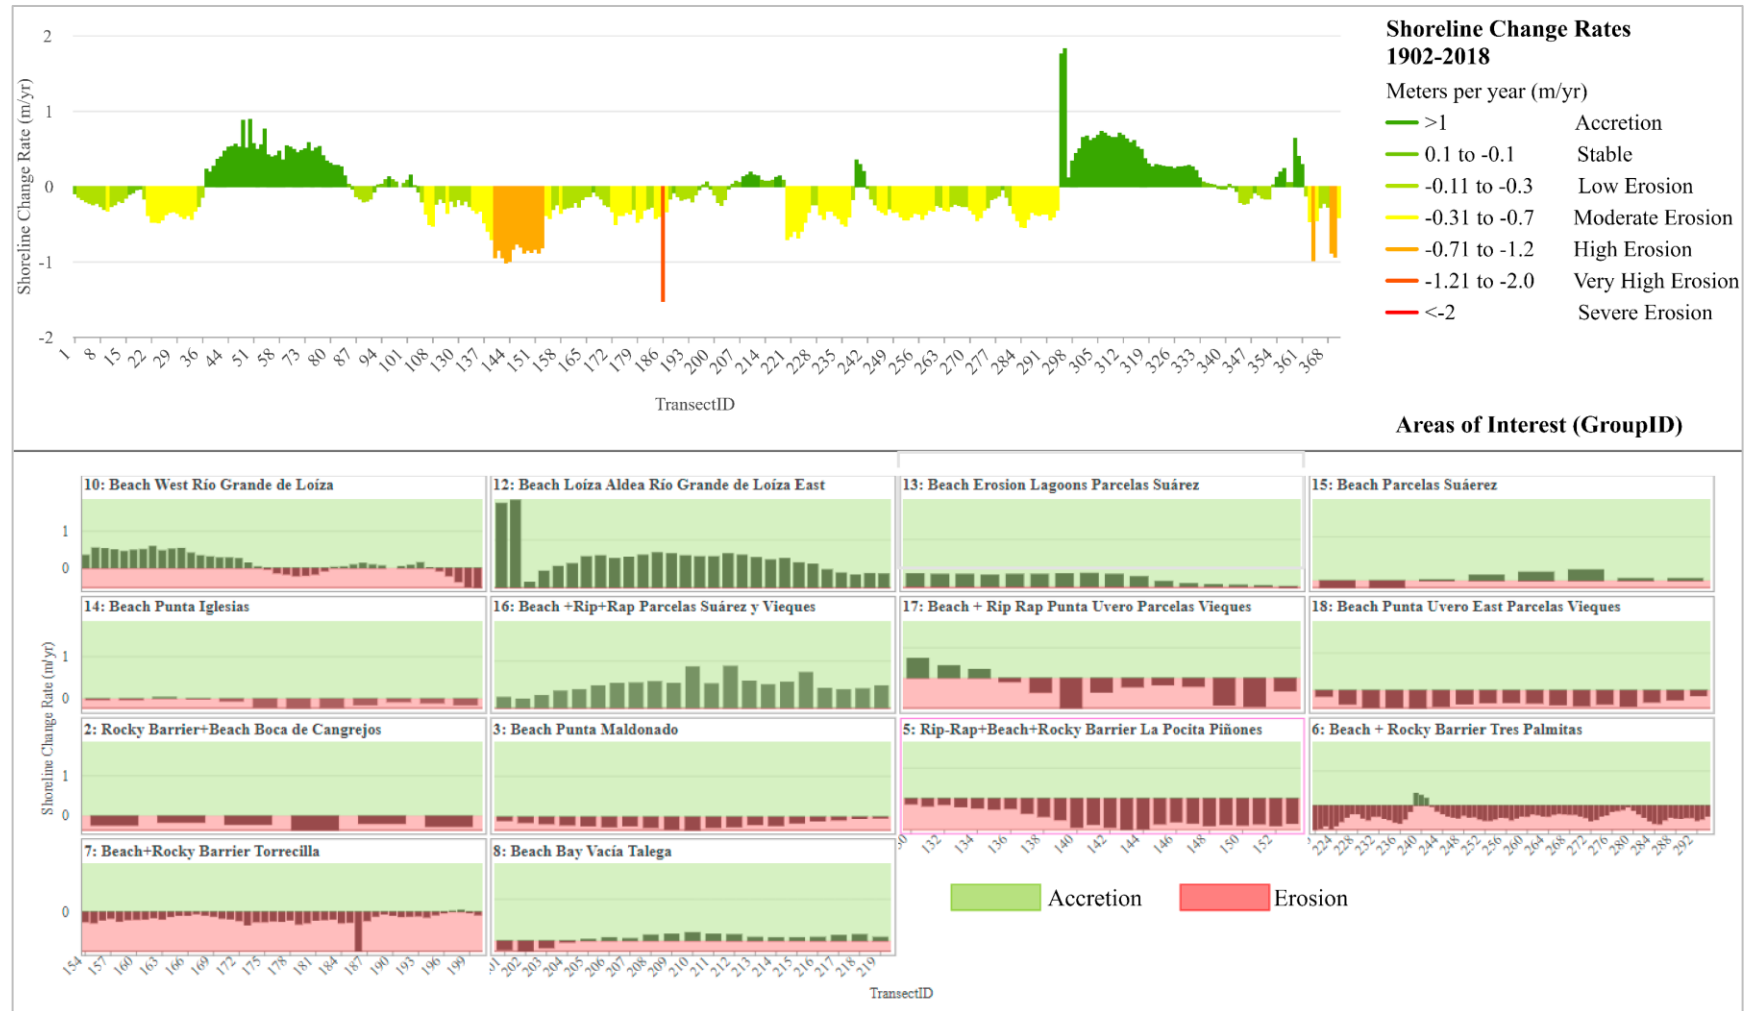
Figure 2.10: Frequencies of Shoreline Change Rates (m/yr) from 1902 to 2018, by Classification (Stewart and Pope, 1993) and GroupID

In the long-term analysis (116 years), from 1902 to 2018, 347 transects were analyzed (Figure 2.10). Overall, the maximum rate of change was 1.83 m/yr (84.87 m), the minimum rate was -1.52 m/yr (-117.62 m), and the average rate was -0.09 m/yr. The maximum accretional rates at the Río Grande de Loíza East beach (GroupID:12), the beach between Parcelas Suárez and Vieques (GroupID:16), and the Río Grande de Loíza West beach (GroupID:10) were 1.83, 0.89, and 0.58 m/yr, respectively.

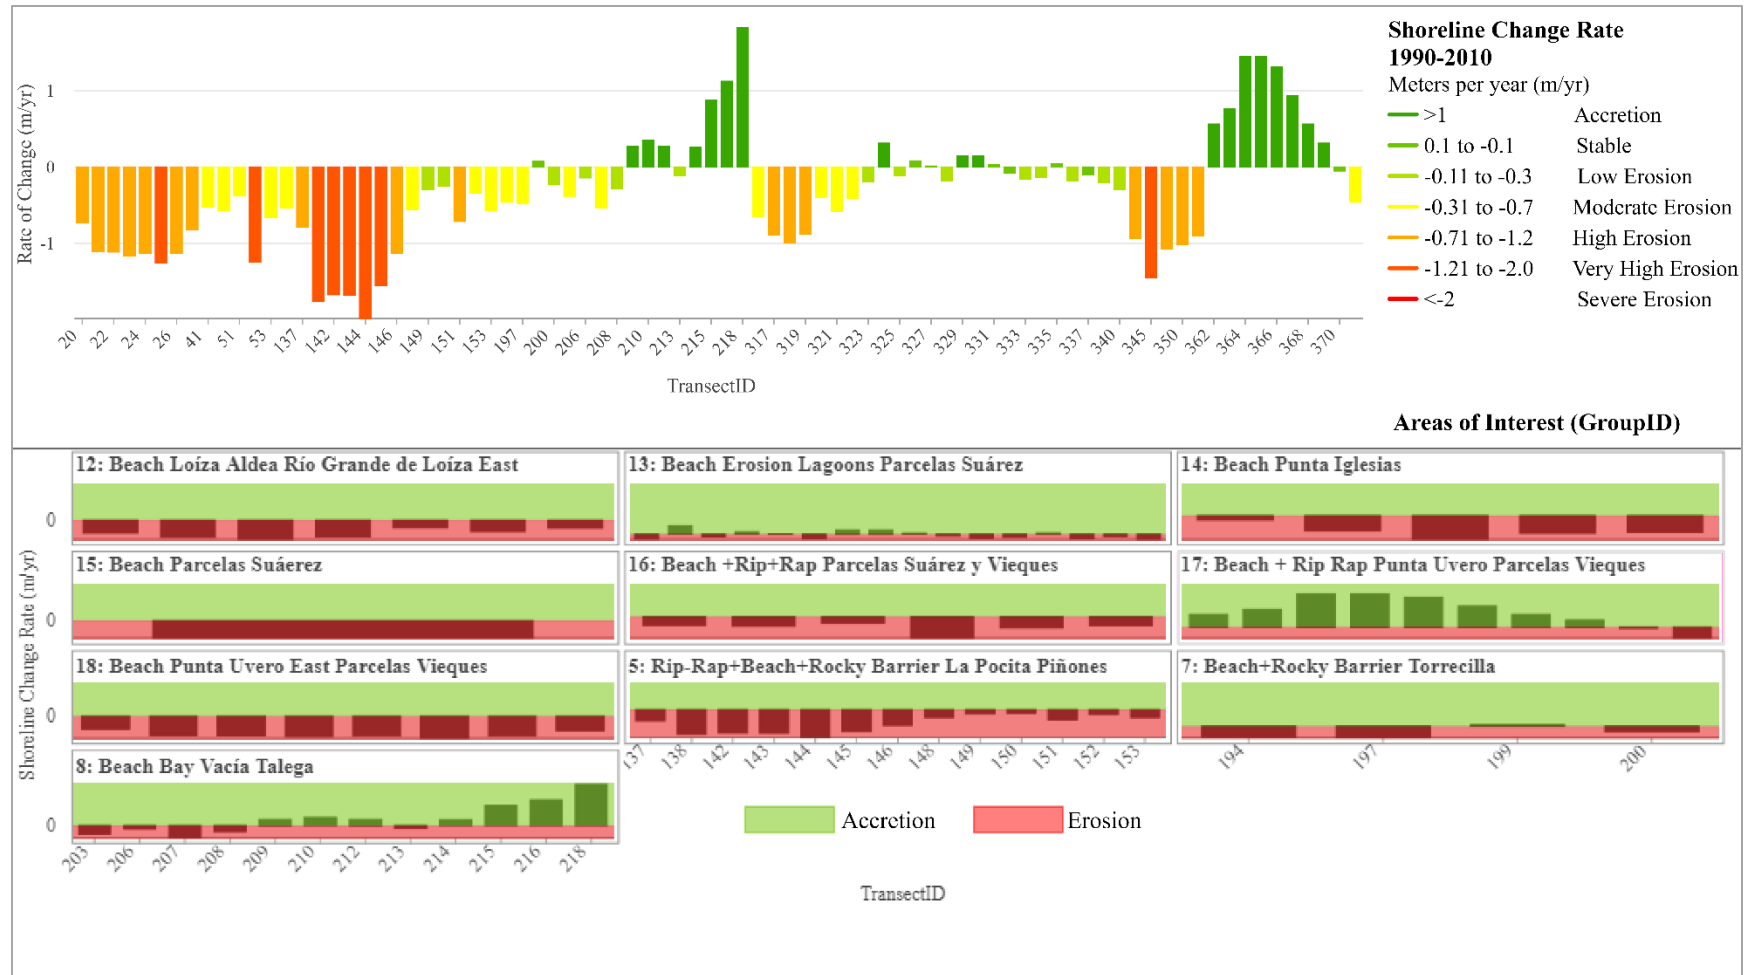
Figure 2.25: Frequencies of Shoreline Change Rates (m/yr) from 1990 to 2010, by Classification (Stewart and Pope, 1993) and GroupID

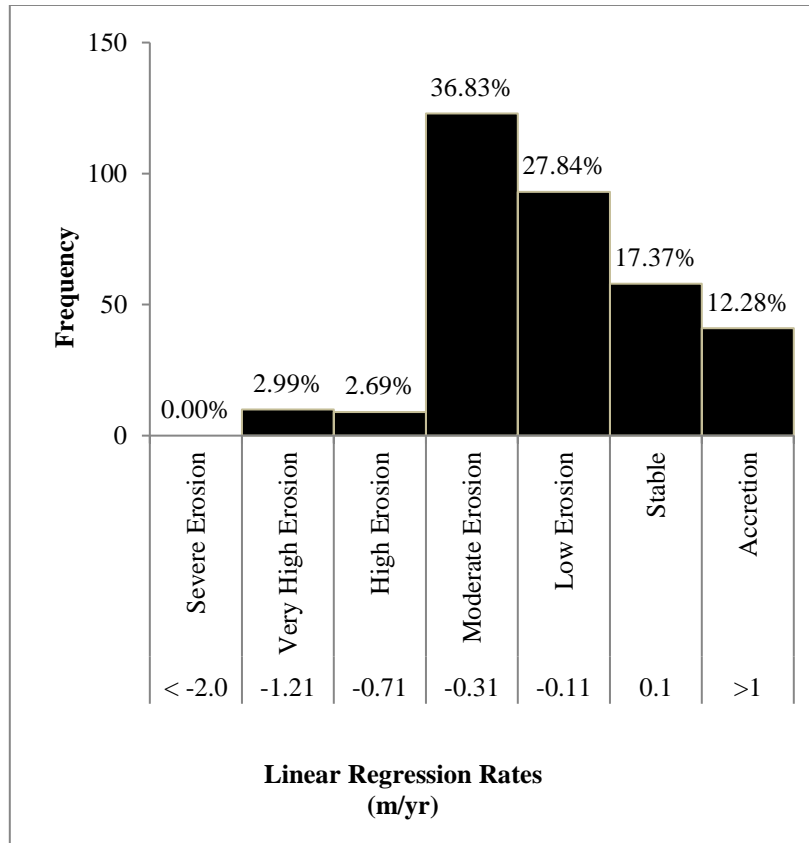
Figure 2.30: Frequencies of Linear Regression Rates for Different Types of Shoreline Change in Loíza, Puerto Rico

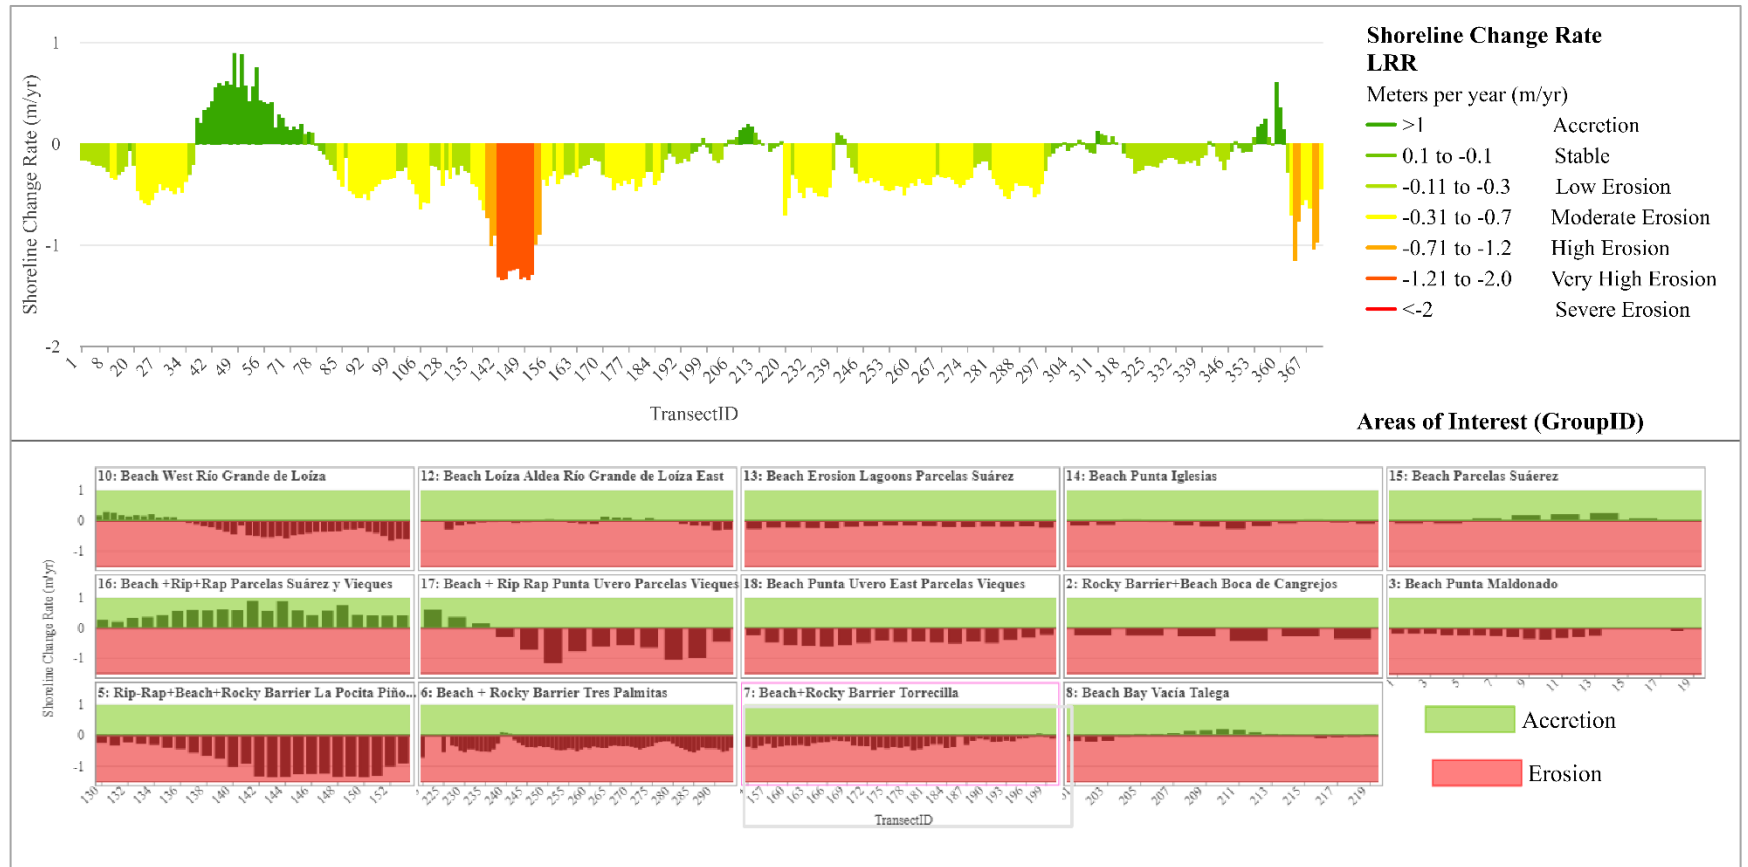
Figure 2.31: Frequencies of Linear Regression Rates (LRR) of Shoreline Change (m/yr) by Classification (Stewart and Pope, 1993) and GroupID

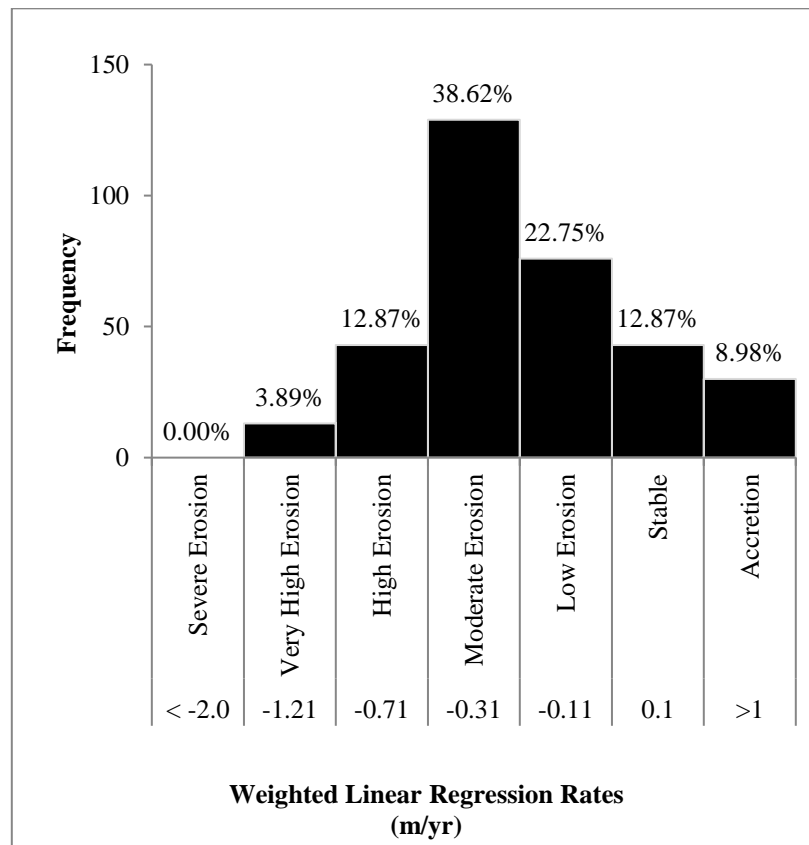
Figure 2.33: Frequencies of Weighted Linear Regression Rates for Different Types of Shoreline Change in Loíza, Puerto Rico

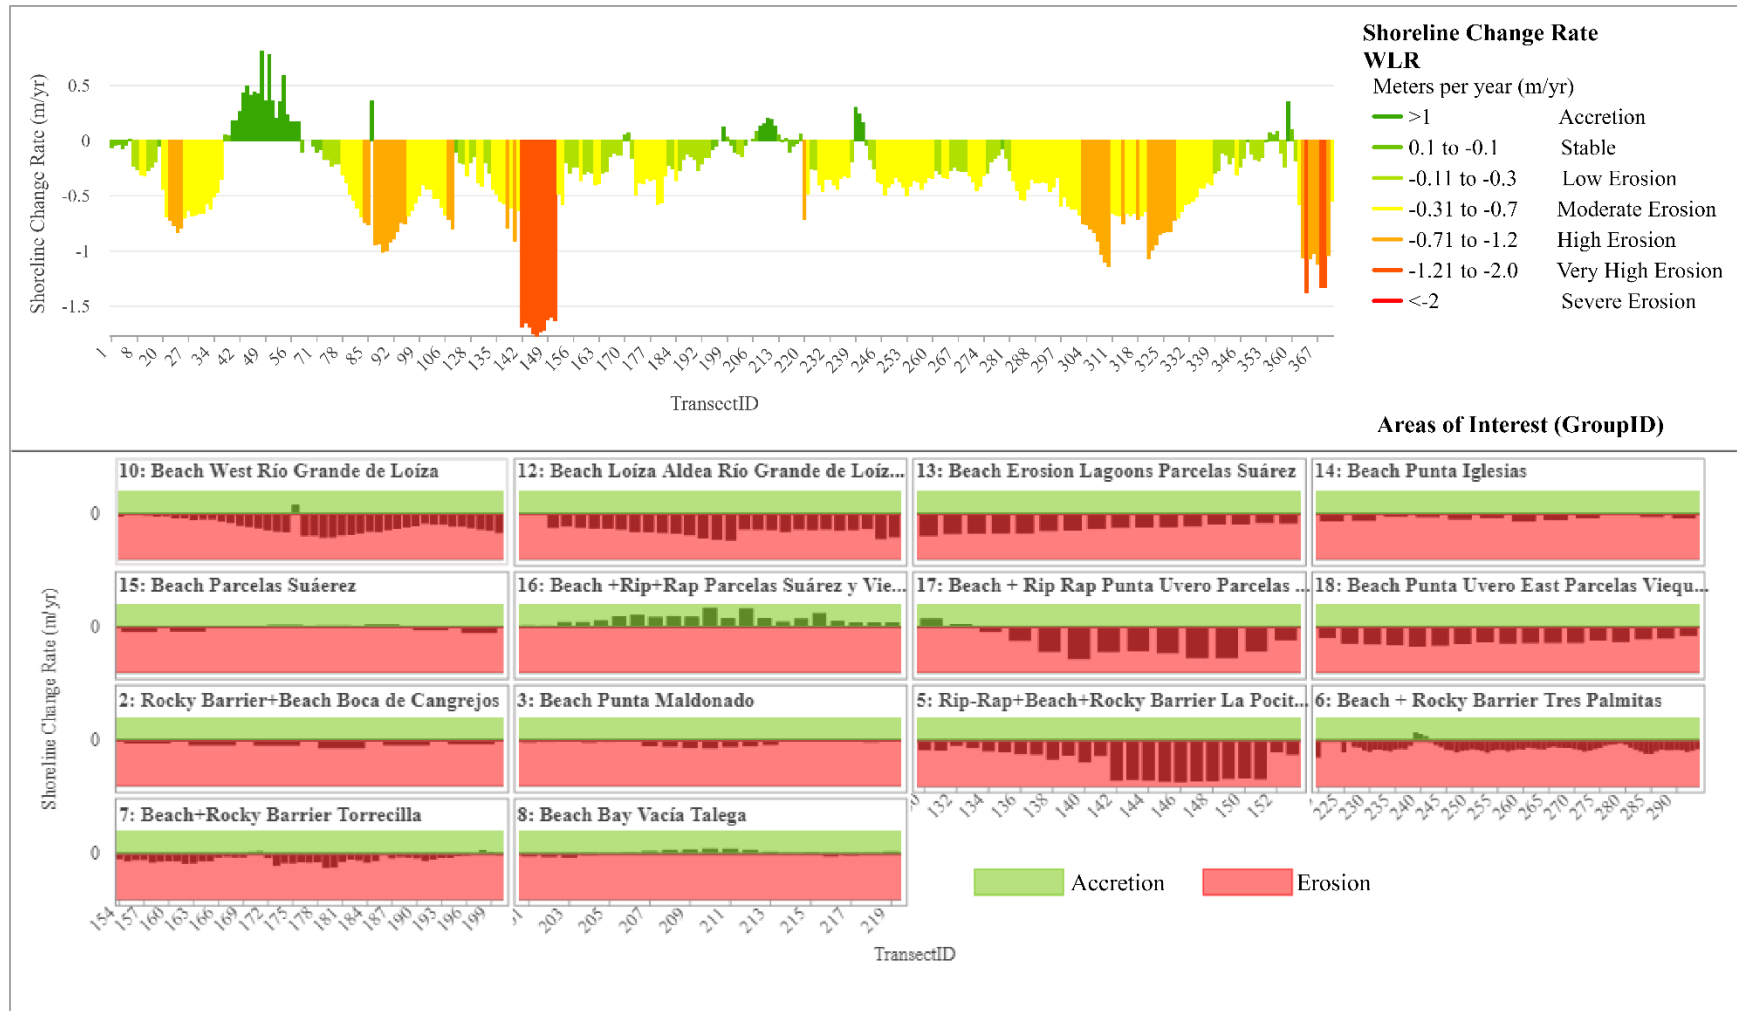
Figure 2.34: Frequencies of Weighted Linear Regression Rates (WLR) of Shoreline Change (m/yr) by Classification (Stewart and Pope, 1993) and GroupID

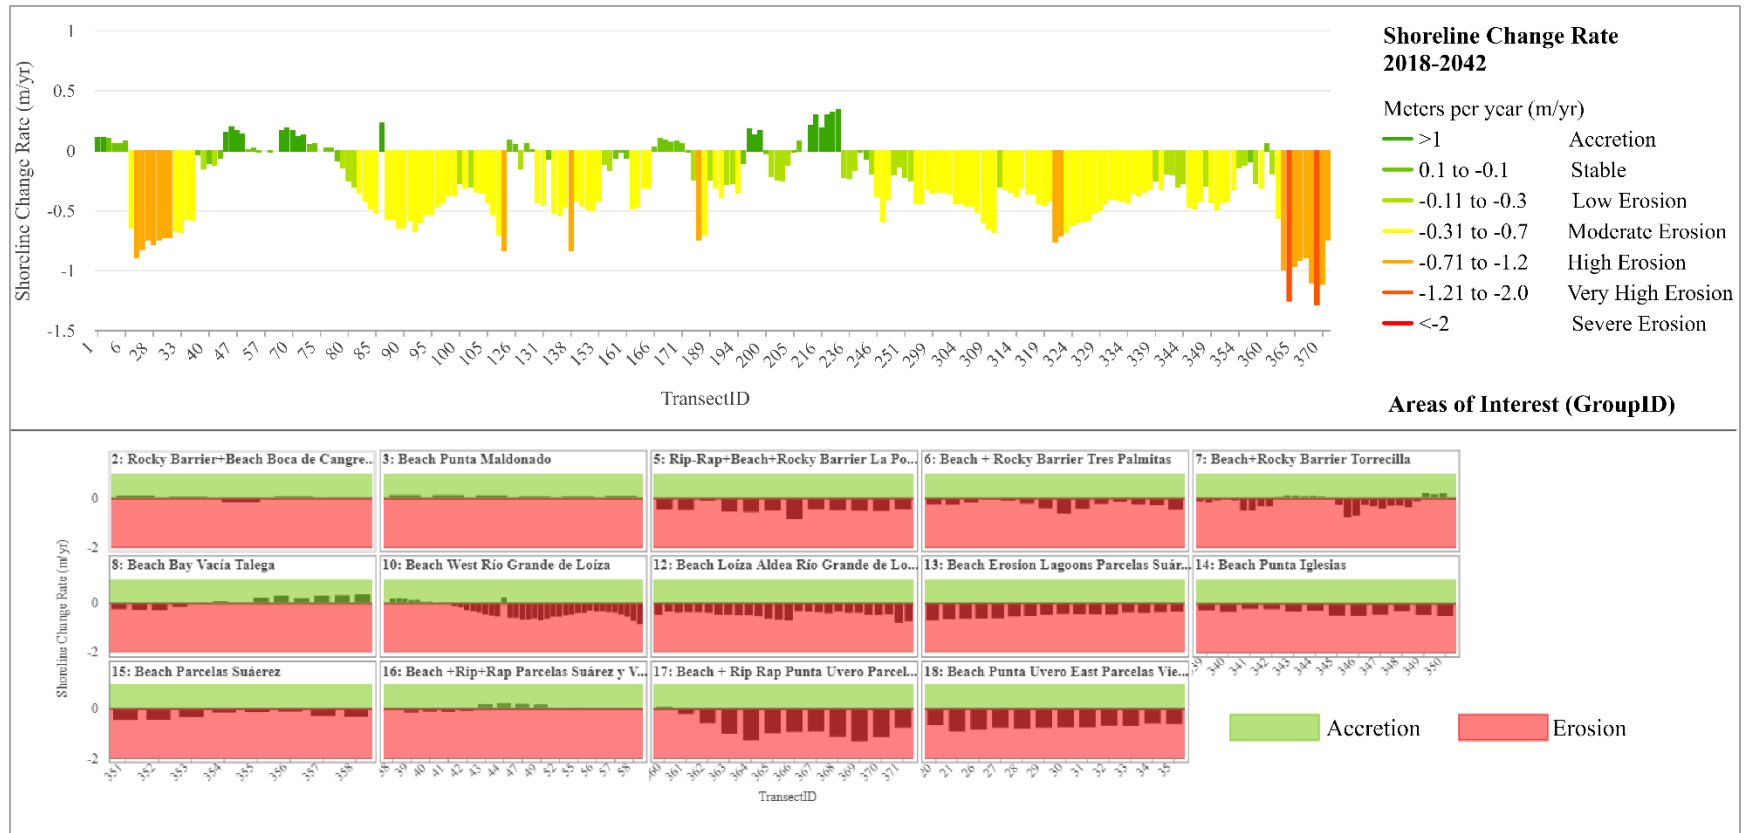
Figure 2.40: Frequencies of Forecasted Shoreline Change Rates (m/yr) from 2018 to 2042, by Classification (Stewart and Pope, 1993) and GroupID

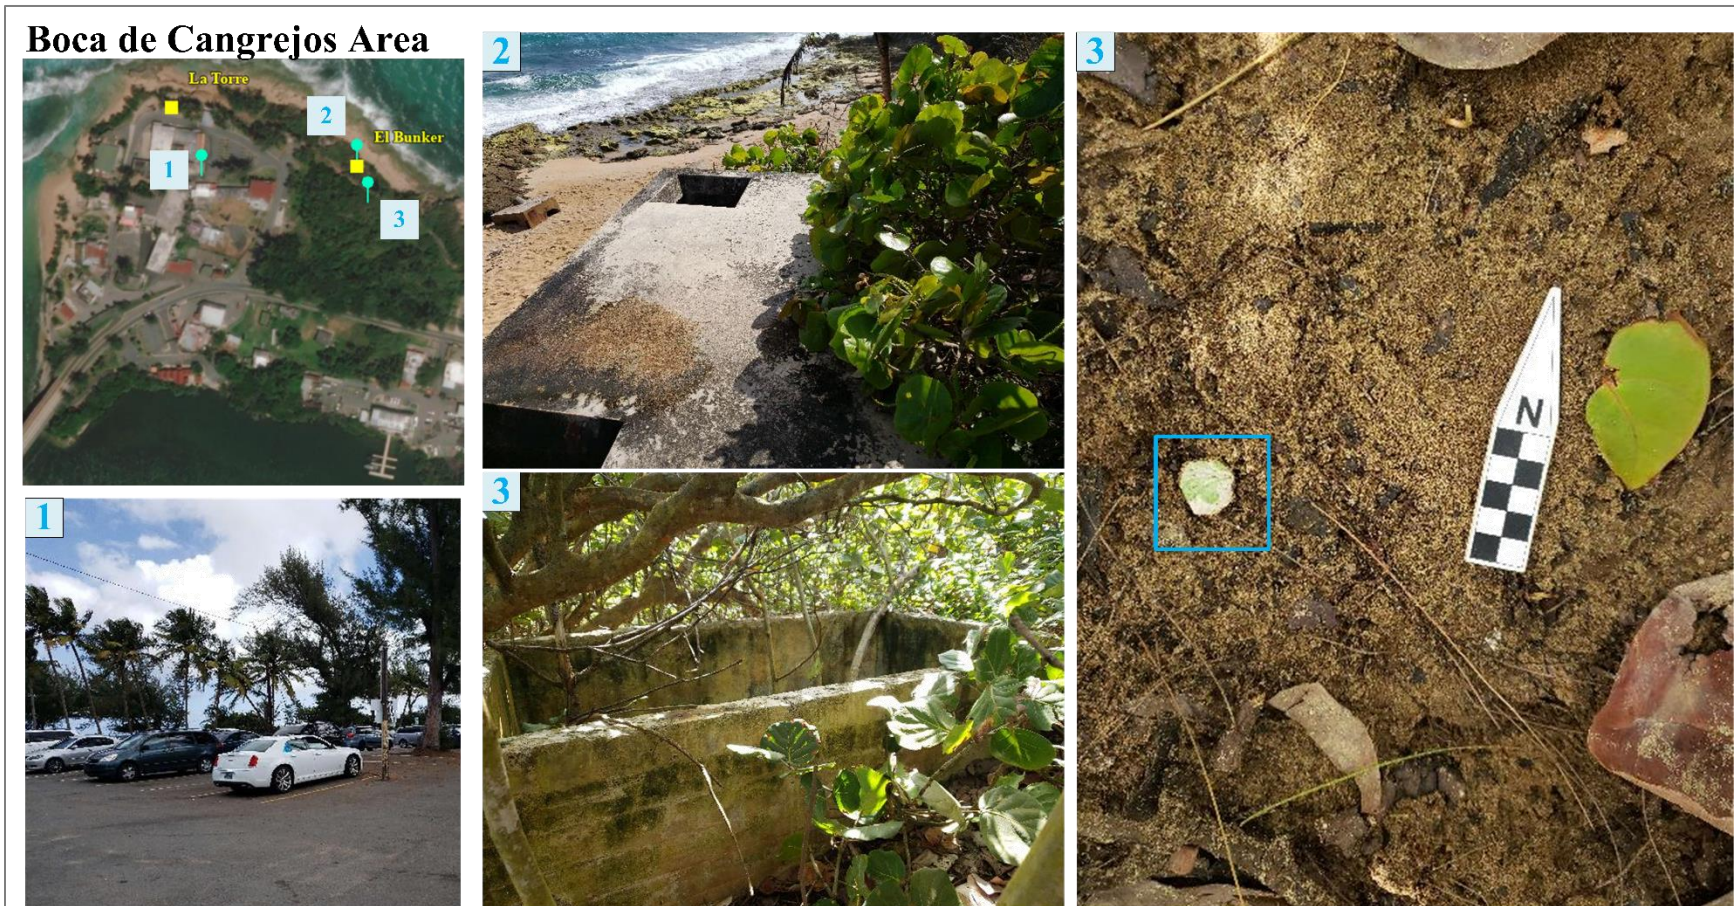
Figure 4.26: Fieldwork in the Boca de Cangrejos area: The Bunker site and other exposed historical materials were found. The blue square shows some of the material found.

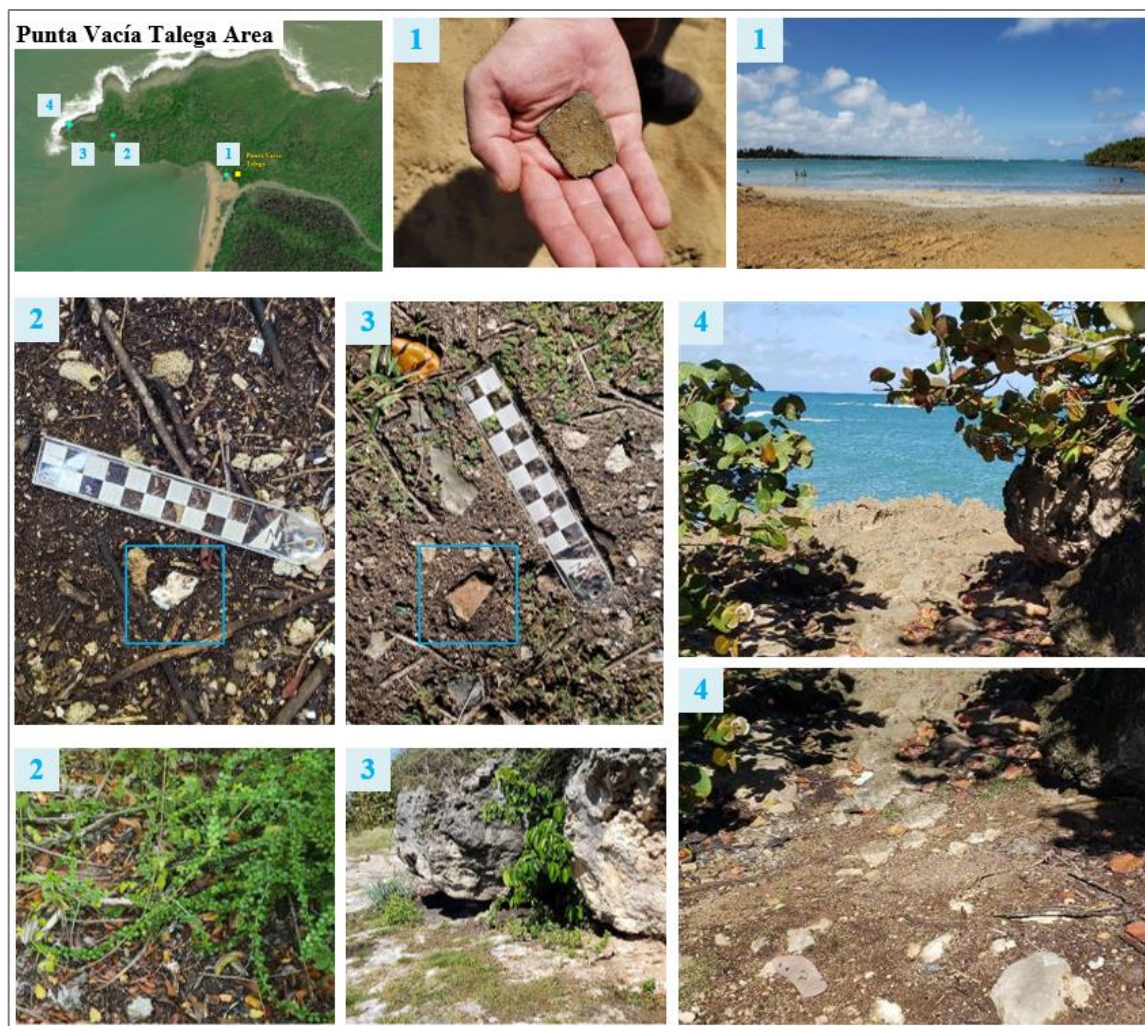
Figure 4.27: Fieldwork findings at Vacía Talega. Blue squares show the materials found.

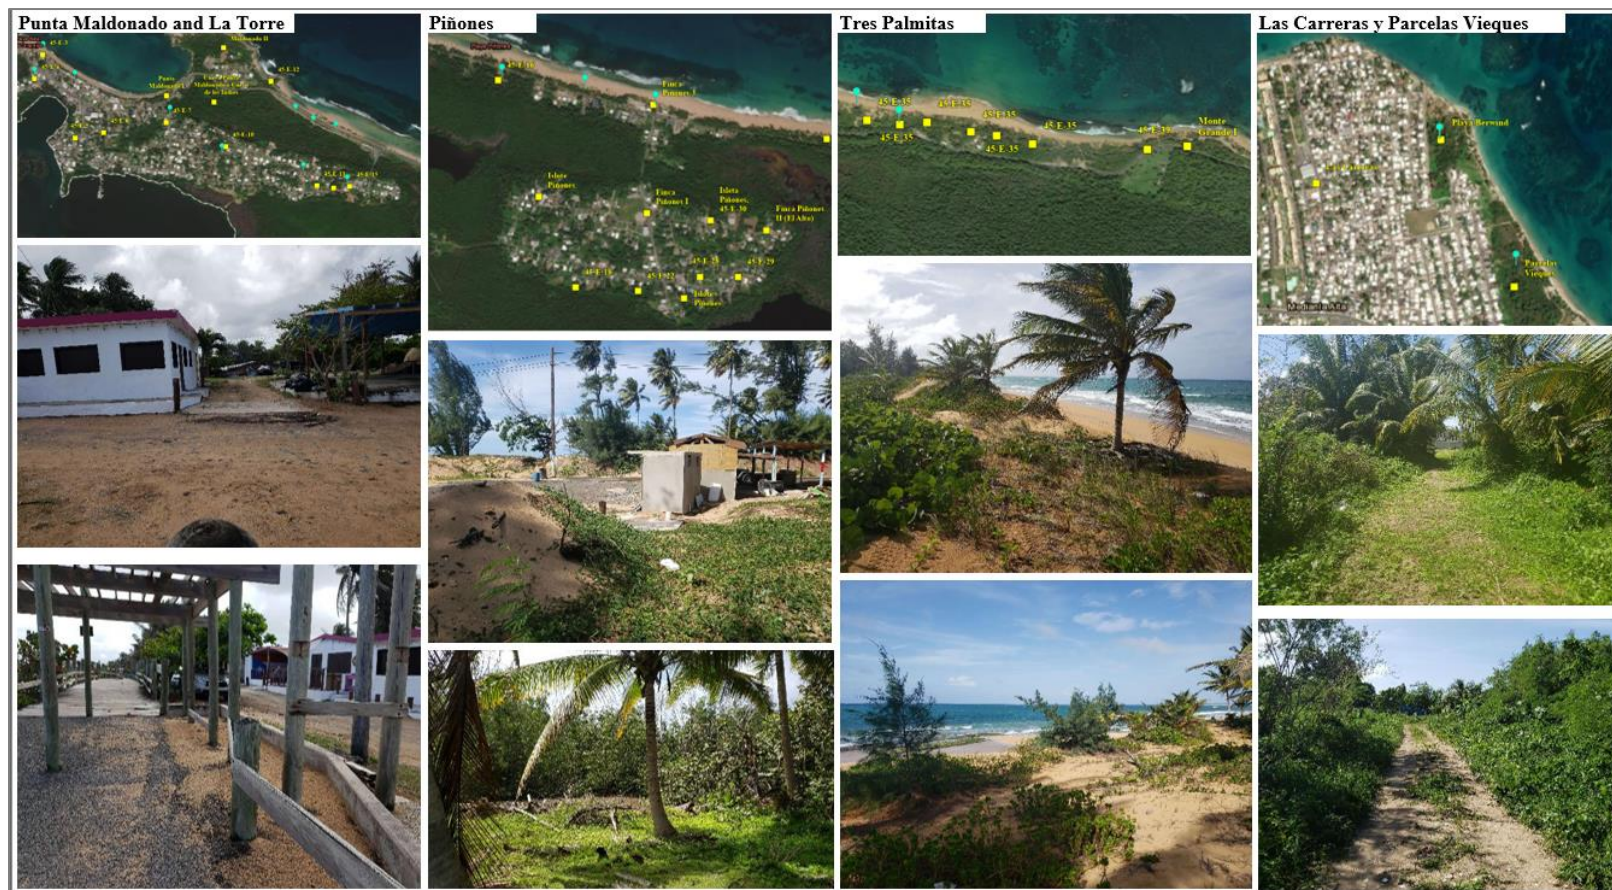
Figure 4.28: Fieldwork visits where no archaeological materials were found

In the other visited areas, materials were not found to indicate the presence of archaeological sites (Figure 4.28). Residence and commercial areas, constructions or dunes were found where archaeological sites have previously been documented. For example, at Tres Palmitas, no materials were found. The dunes have highly recovered this area, so sites could be buried beneath them. A new commercial area has been established near the Finca de Piñones site, and no archaeological materials were found. The La Torre area mainly comprises residential areas now, with no access to the exact locations of previously documented sites. In this area, several constructions and mounds of construction materials were observed.

Other sites, such as Playa Bergwind, Punta Uvero, and Parcelas Vieques, were visited using the UAS. In this regard, no materials were found, and no further information could be extracted from the aerial images taken by the drone. The images revealed the dirt roads that are present and connect the Río Herrera area with Parcelas Vieques.
